ti MEMORANDUM ON
MERCURY-REDSTONE BOOSTER DEVELOPMENT
FLIGHT (MR-BD) ~~(*)~~ (C) (**)

Author: Jerome B. Hammack
Patrick AFB, Fla. 26 Mar. 1961
(over)

NASA - Space Task Group
Patrick Air Force Base, Florida
March 26, 1961

Subject: Mercury-Redstone booster development flight
(MR-BD)

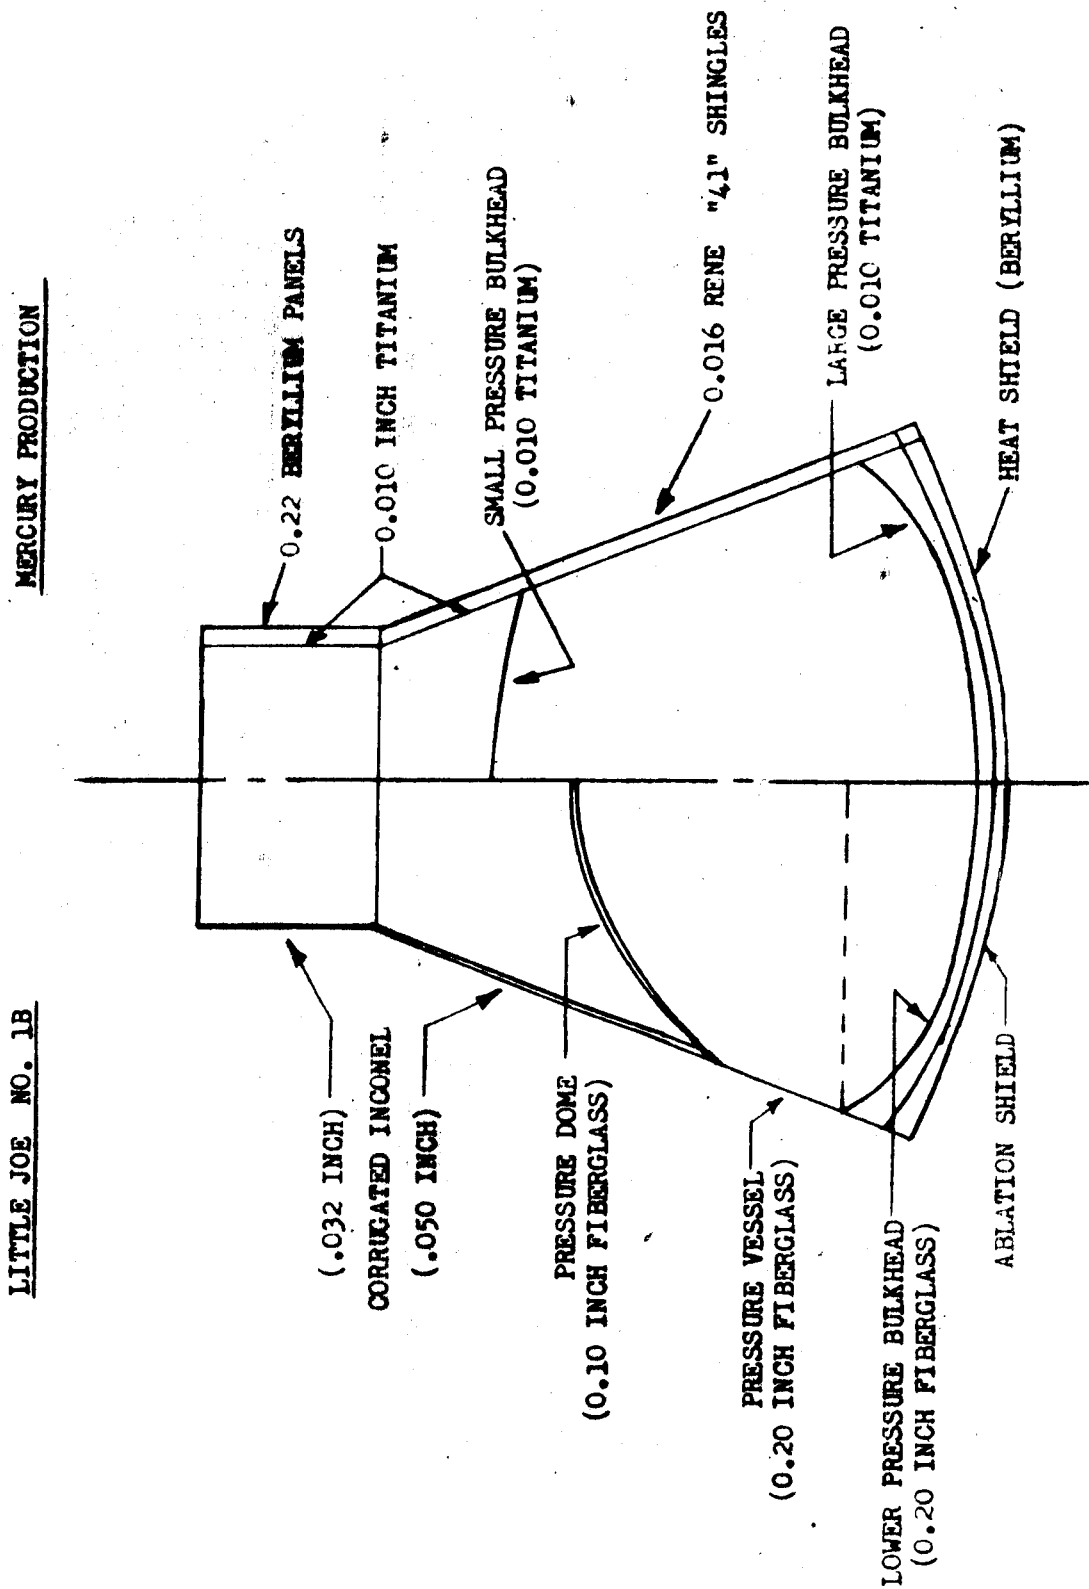
FIGURE NO.1.- COMPARISON OF CONSTRUCTION OF A LITTLE JOE AND A MERCURY PRODUCTION CAPSULE.

3. Capsule Description. - The capsule utilized for the MR-BD flight was designed and built by NASA-Langley Research Center for the Little Joe 1B flight test made in January, 1960 at Wallops Island, Virginia. It was ballasted and configured to simulate a Mercury production capsule (specifically, Capsule No. 7). A comparison of construction details between this capsule and the Mercury production capsule is shown in Figure 1. The escape system was standard Mercury configuration utilizing spent rocket motors ballasted to proper weight.

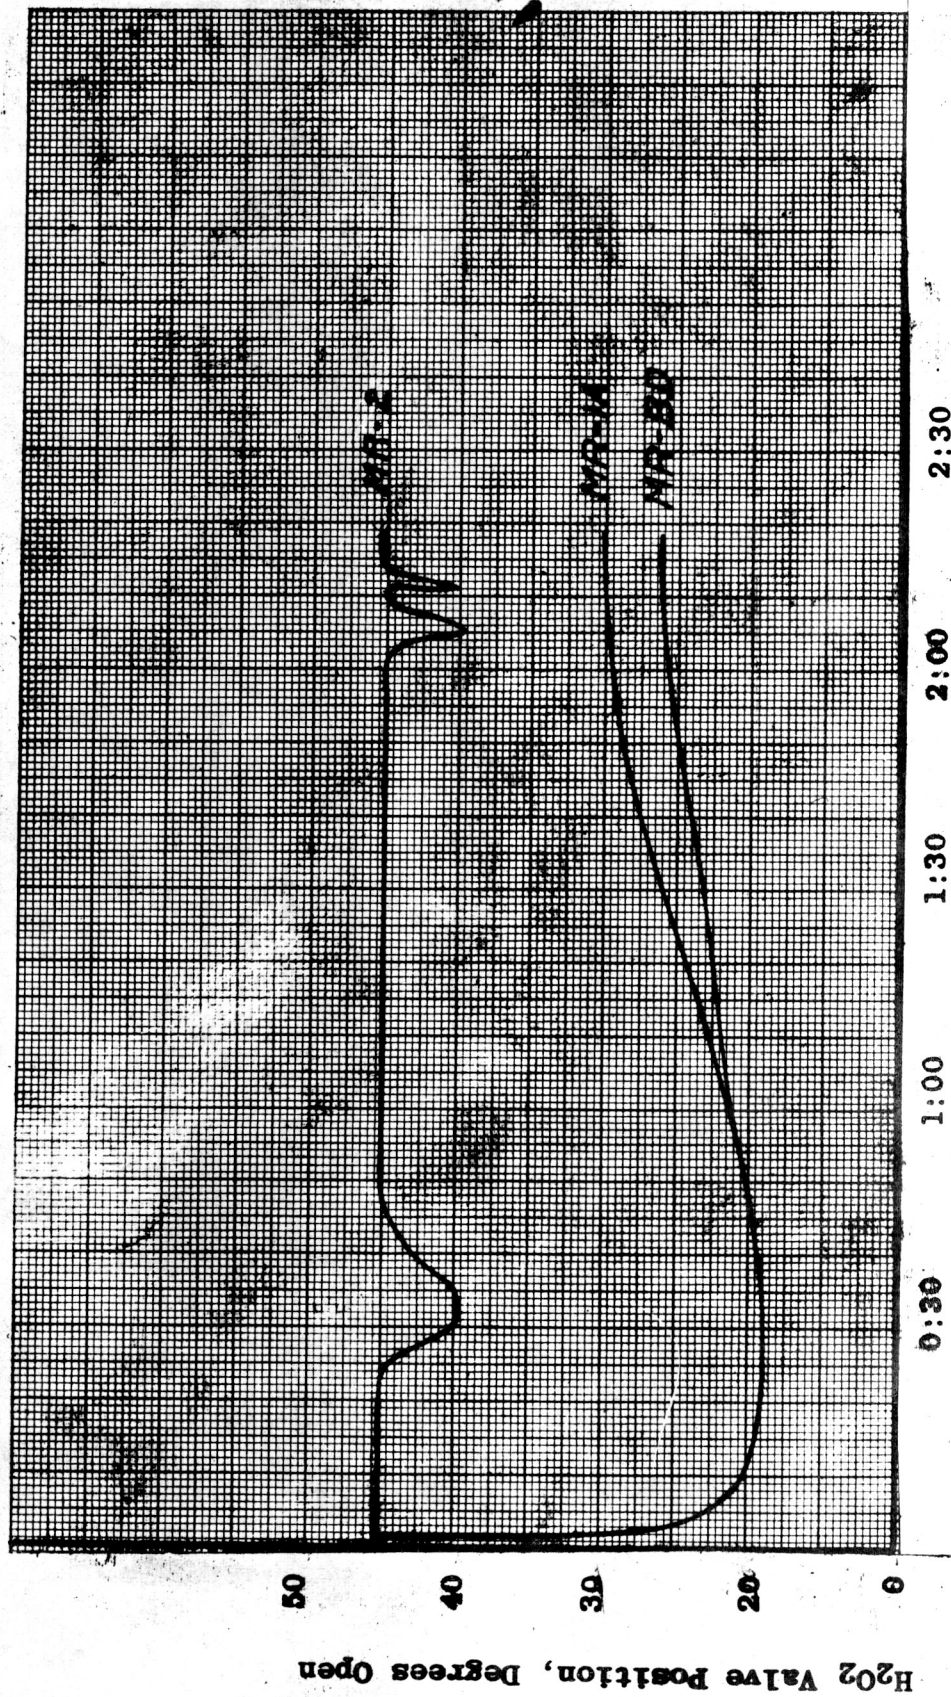
FIGURE NO. 4. - HYDROGEN PEROXIDE VALVE BLADE POSITION VERSUS TIME

(c) Thrust Controller. - The servo control valve which regulates H_2O_2 flow to the steam generator functioned normally as can be seen in Figure 4. This in turn gave optimum propellant flow which resulted in normal combustion chamber pressure as can be seen in Figure 5. After stabilization of pressure, a constant value of 317 PSIA was maintained throughout the flight. It is, therefore, assumed that the corrective action taken as stated in the reference memorandum regarding the thrust controller system was sufficient to overcome the difficulties that were encountered on the MR-2 flight.
